Subject: Rubbing Noise From Rear of Vehicle (Install Retainers to Wheel Liner) #06-08-65-001 - (04/28/2006)

**Models: 2006 Pontiac Solstice
2007 Saturn Sky**

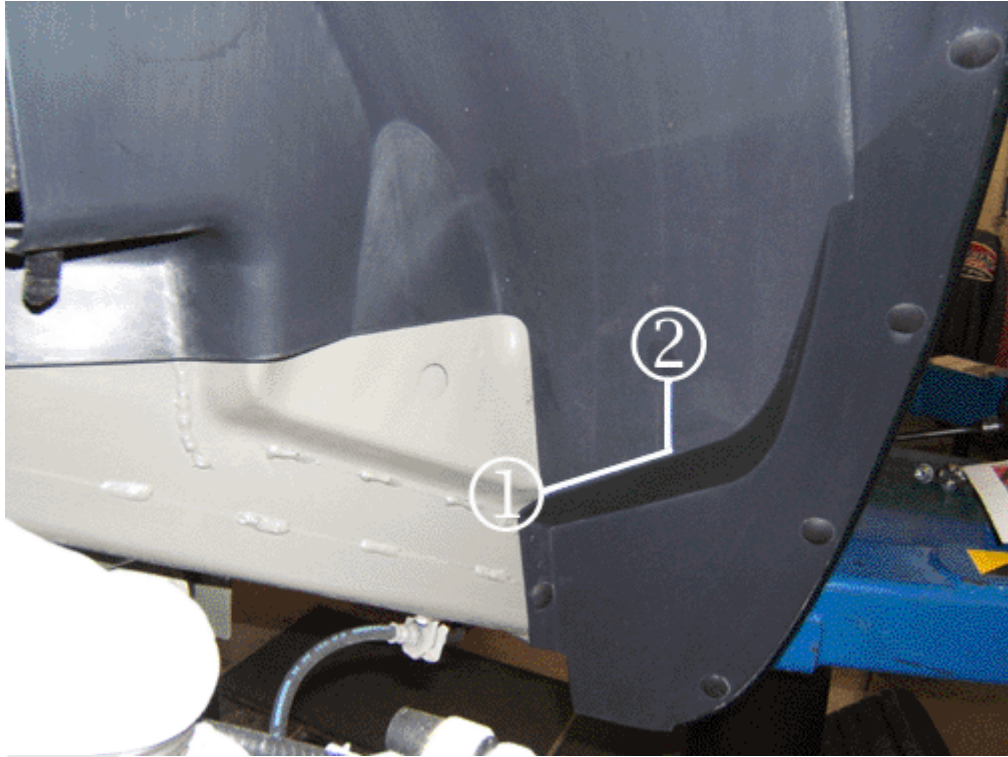
Some customers may comment on a rubbing noise from the rear of the vehicle.

This condition may be caused by the inner wheel liner making contact with the tire .

2. Make a measurement from the corner 90 mm (3 ½ in). The second measurement will be to measure up 40 mm (1 ½ in). Refer to the illustration.
3. Drill a hole through the plastic wheel liner and the sheet metal using a 6 mm (15/64 in) drill bit.
4. Drill the hole larger in the plastic liner using a 8 mm (19/64 in) drill bit to eliminate contact with the retainer.
5. Apply SuperLube® with PTFE, P/N 12371287 (in Canada, P/N 10953437), to the end of the retainer and install the new retainer. You must push firmly on the retainer to fully seat it.
6. Install the wheel and tire.
